**KAATZ, BINKLEY, JONES, & MORRIS ARCHITECTS, INC.**  
**ARCHITECTS – ENGINEERS – EDUCATIONAL PLANNERS**

William T. Morris, AIA    Larry D. Marvel, AIA    Gary C. Kromer, RA    Jason Morris, AIA

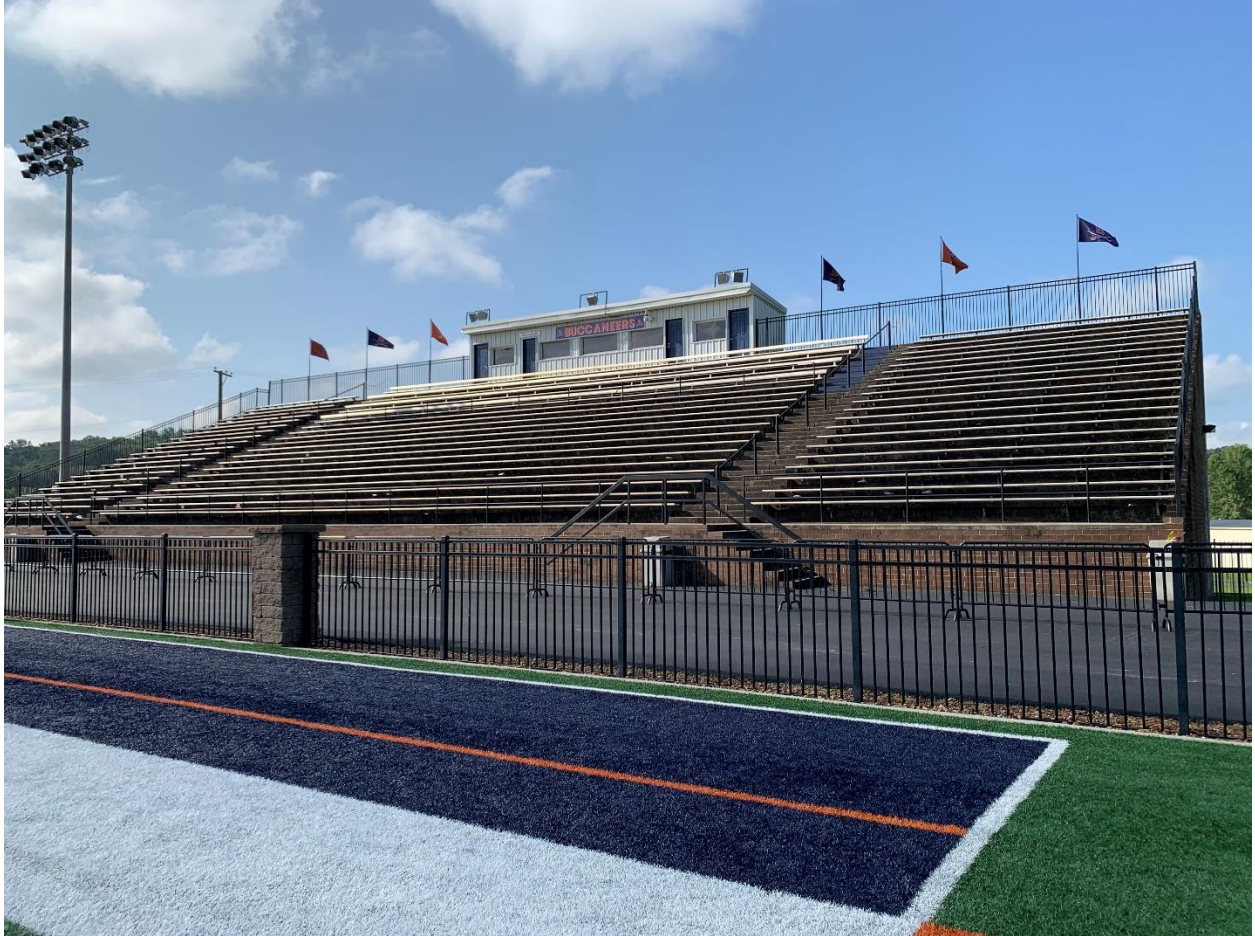
## DESCRIPTION OF STRUCTURE

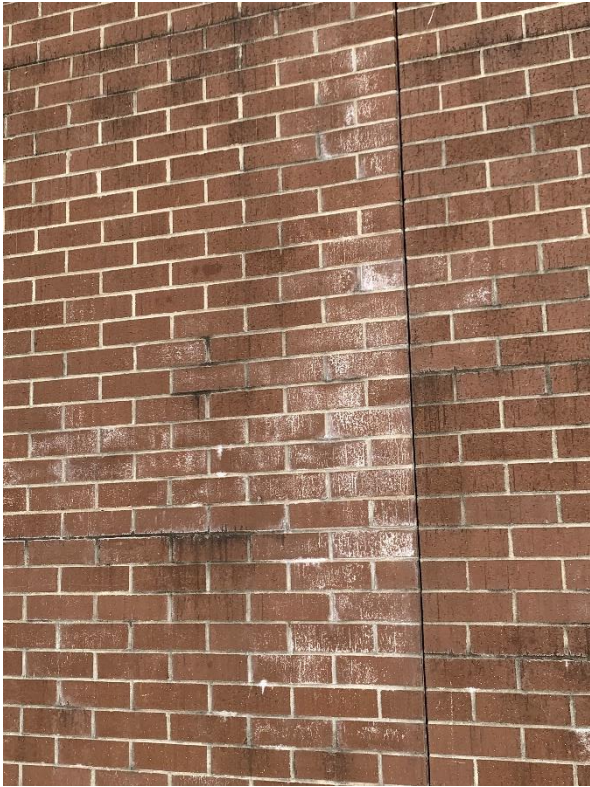
Efflorescence on brick veneer.

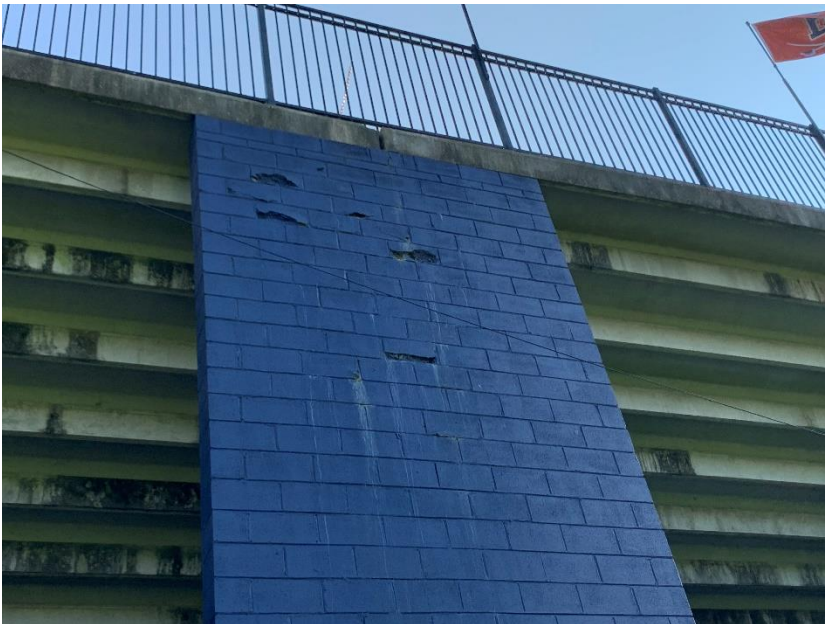
Spalling masonry along rear wall.

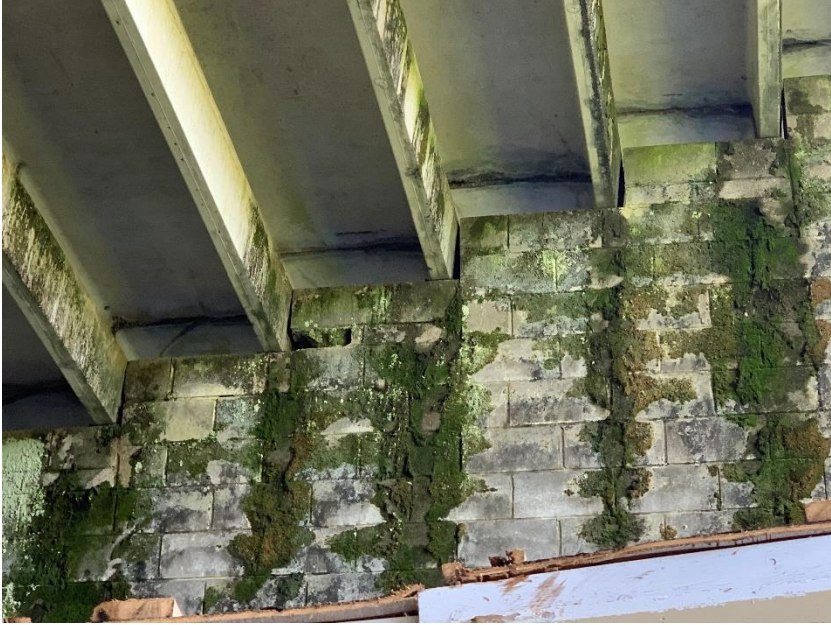
Water infiltration, moss growth, cracking and loss of section in interior masonry wall.

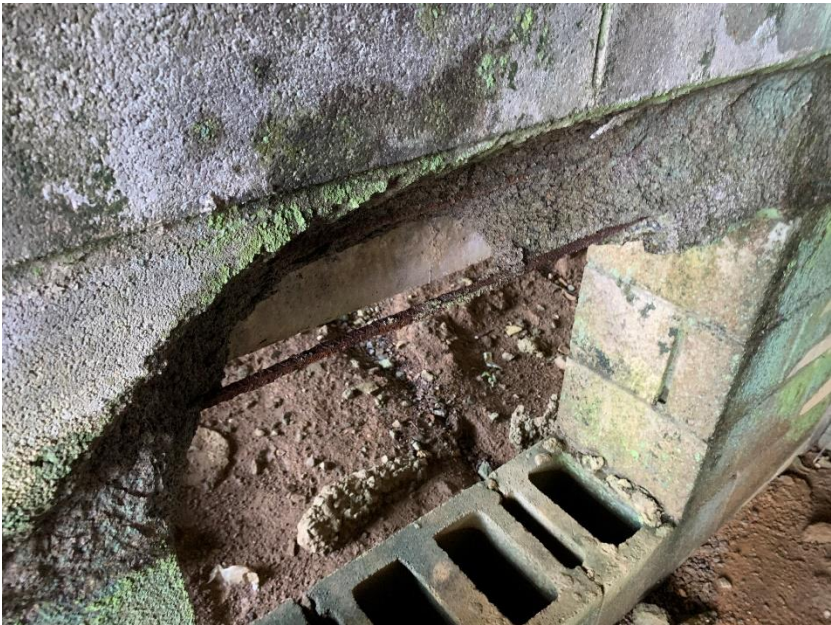
Loss of masonry and grout with exposed reinforcing in masonry lintel.

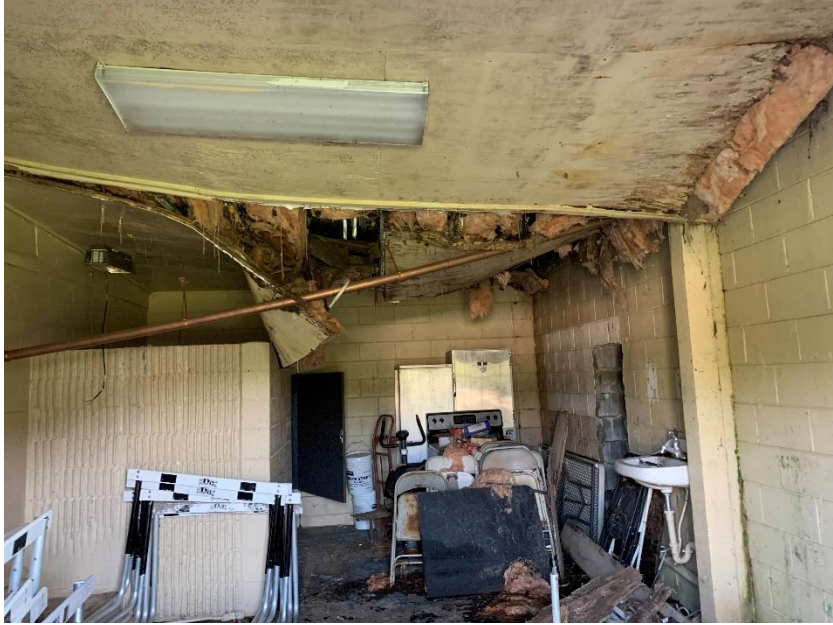
Water infiltration to built-out area beneath bleachers.

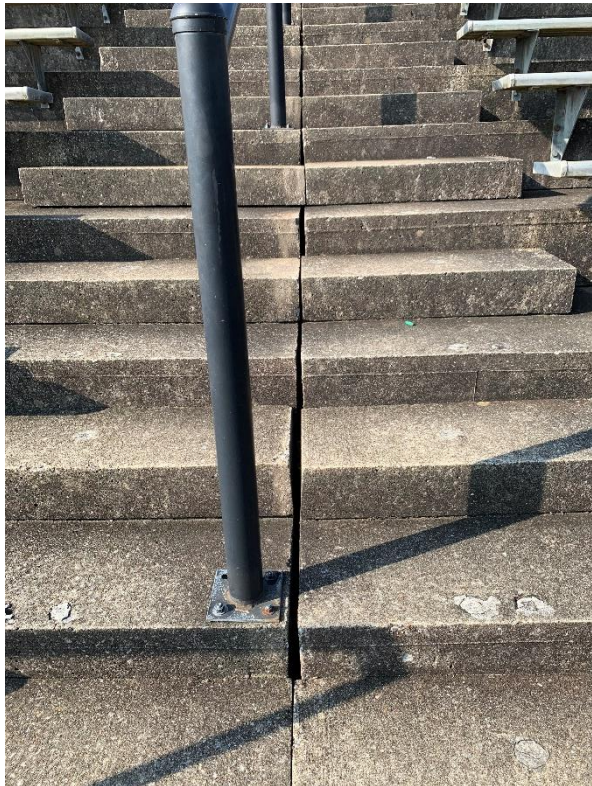
Absence of joint sealant between concrete planks.

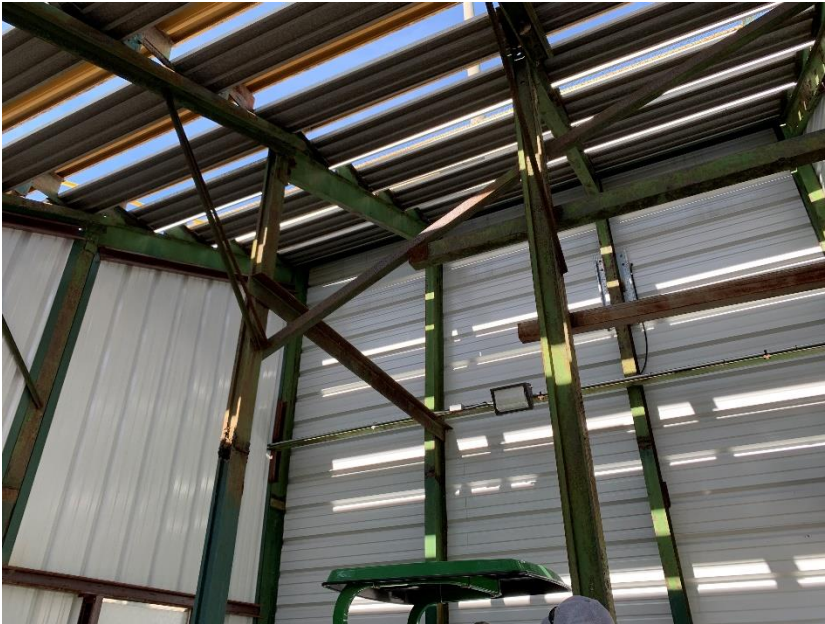
Example of interior framing with railroad rail columns and beams, and diagonal bracing.

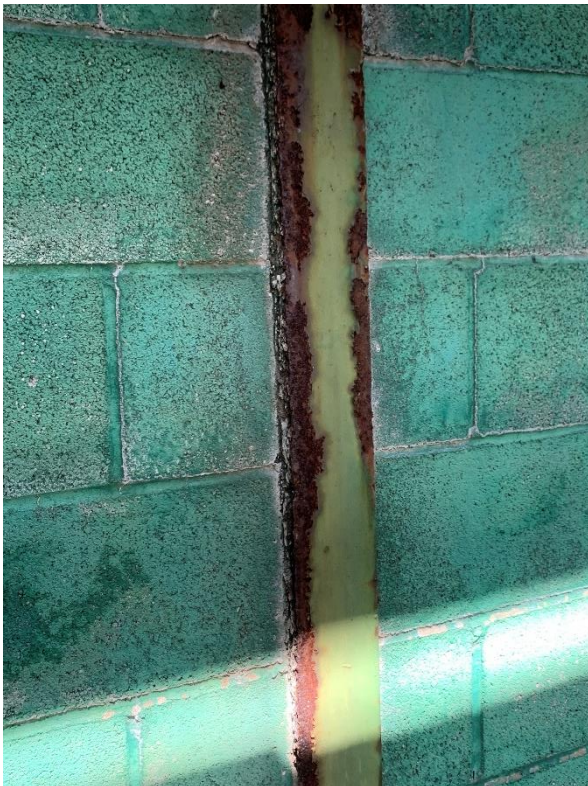
Corrosion of column flanges in contact with masonry walls.

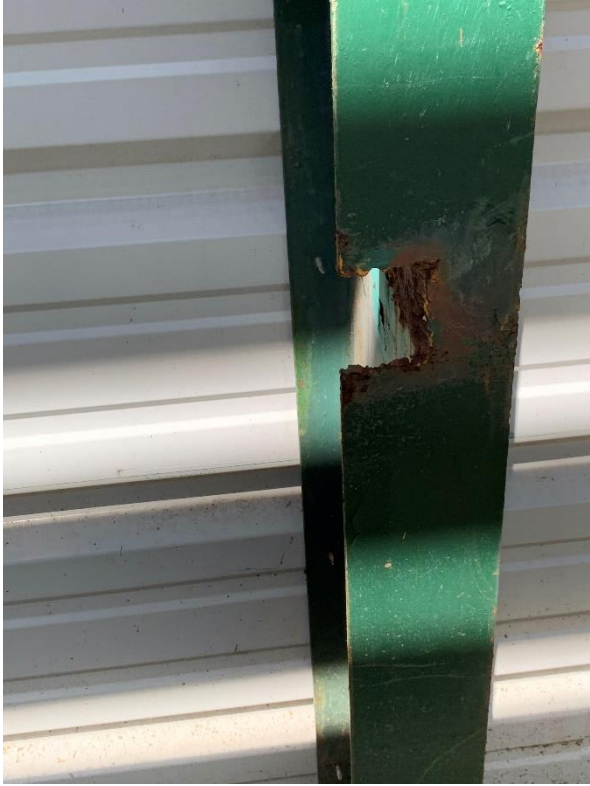
Example of notched column flange.

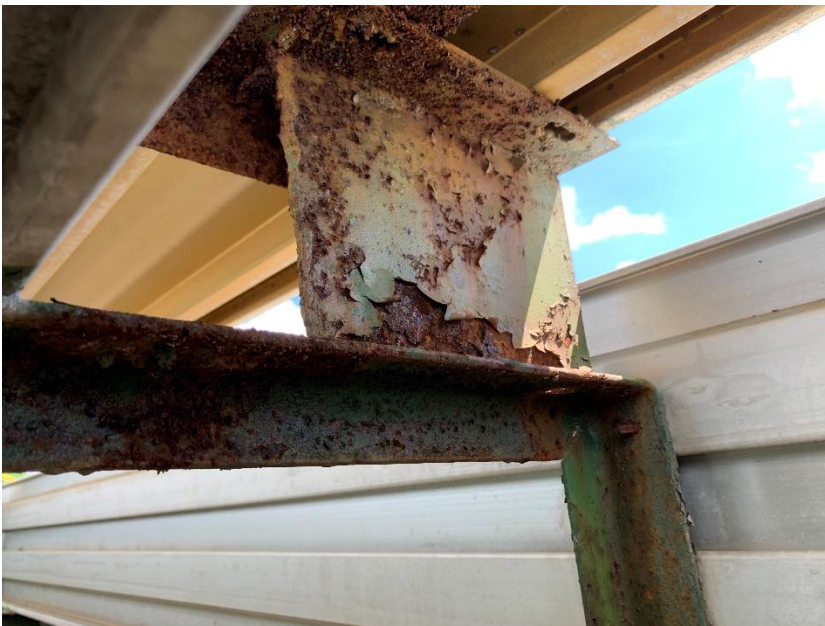
Example of rusted seat bracket.

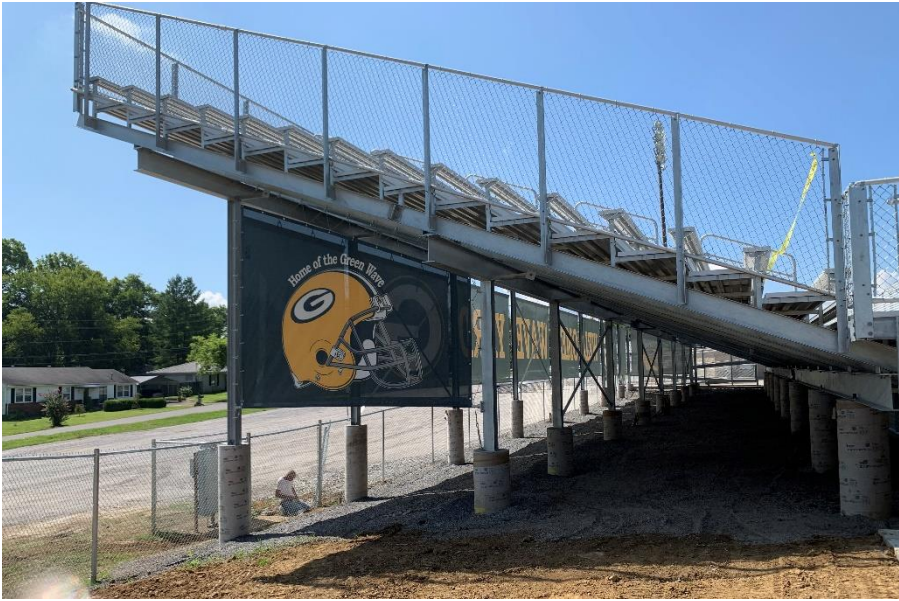
New Visitor side galvanized steel bleachers on sonotube foundations.

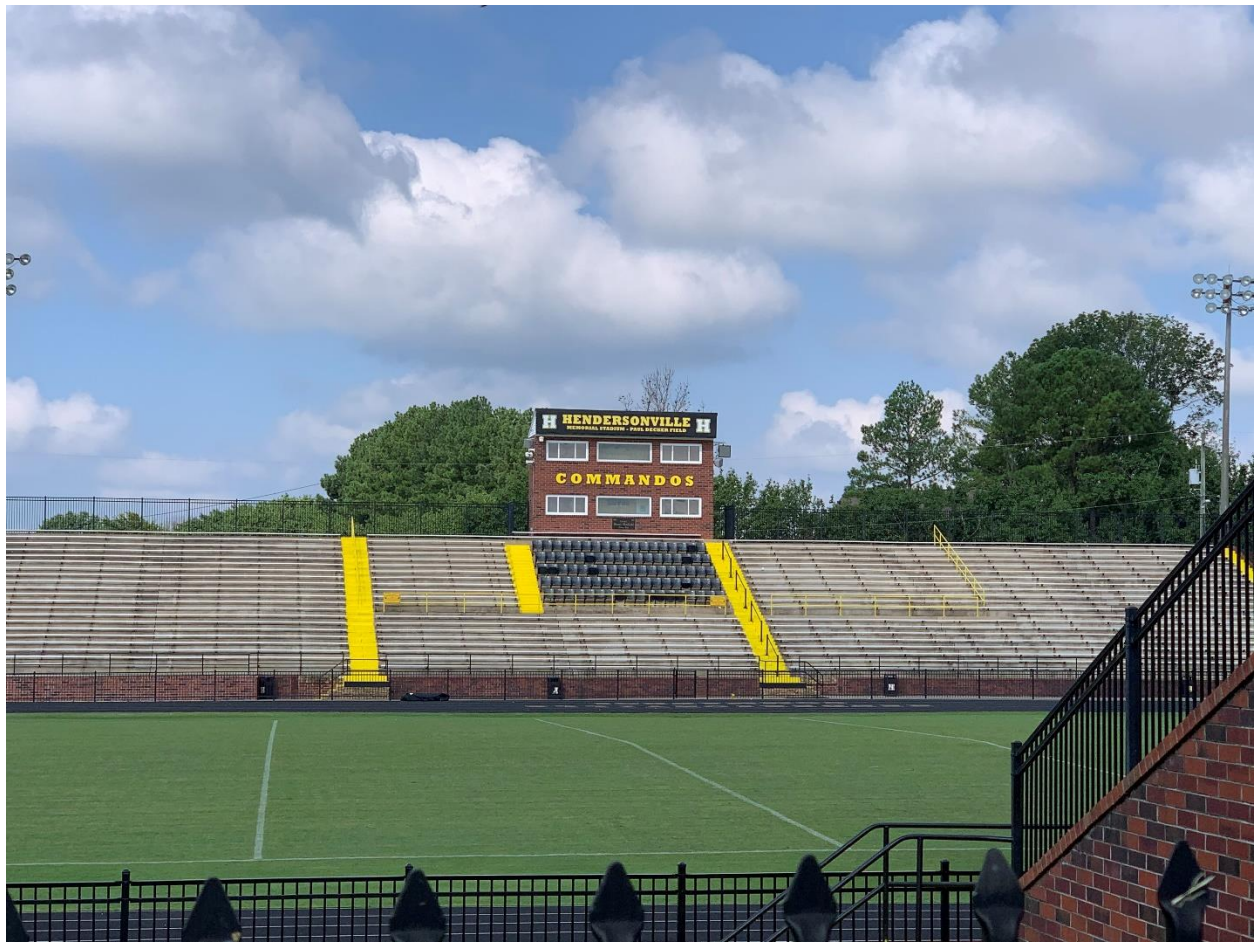
## DESCRIPTION OF STRUCTURE

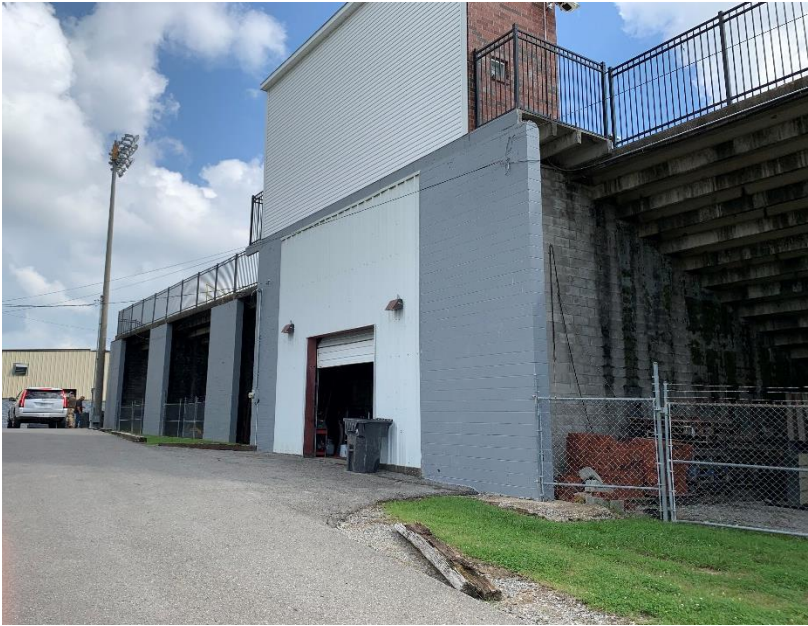
Back side of Home side bleachers.

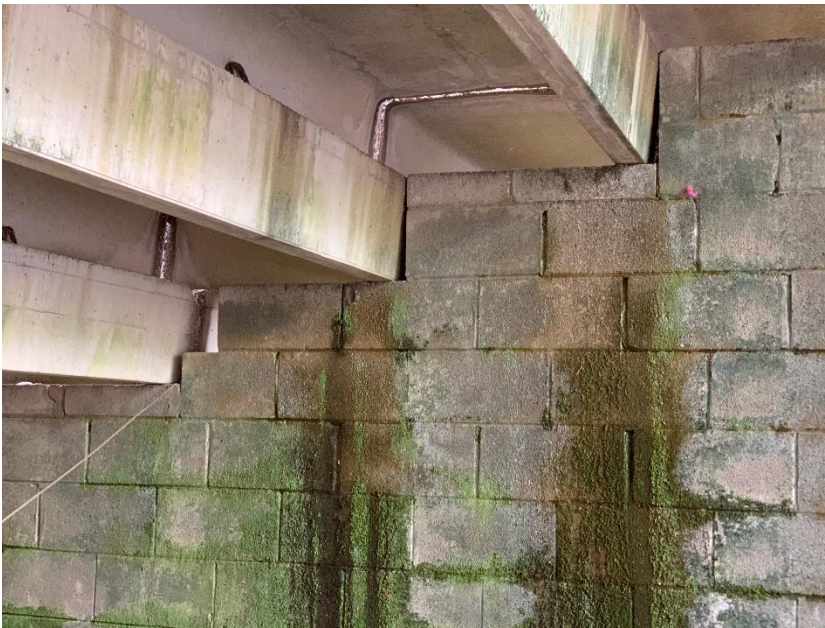
Interior Home side masonry walls with water infiltration and moss growth.

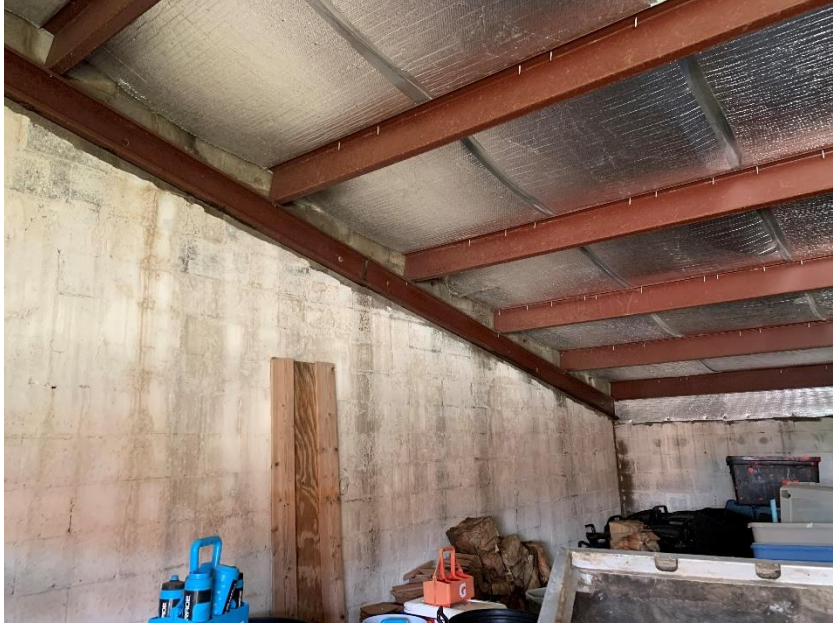
Interior masonry built-out space below Home side bleachers without water infiltration.

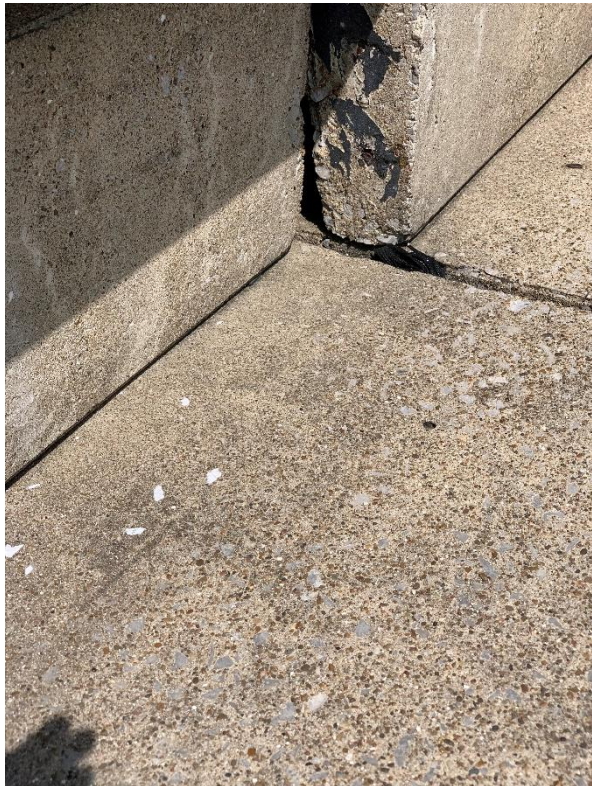
Single displaced concrete plank on left side section of Home side bleachers.

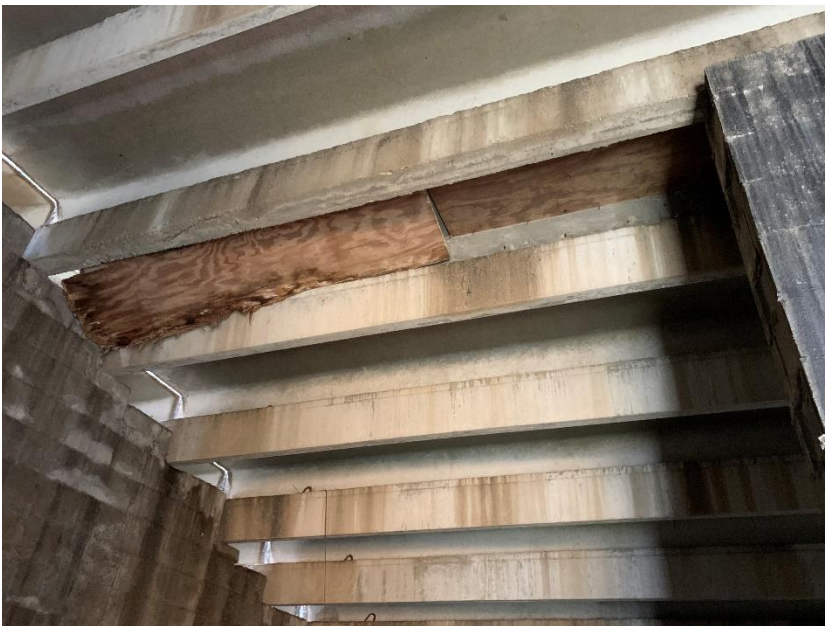
Previous repair to concrete plank and infill masonry wall providing intermediate support.

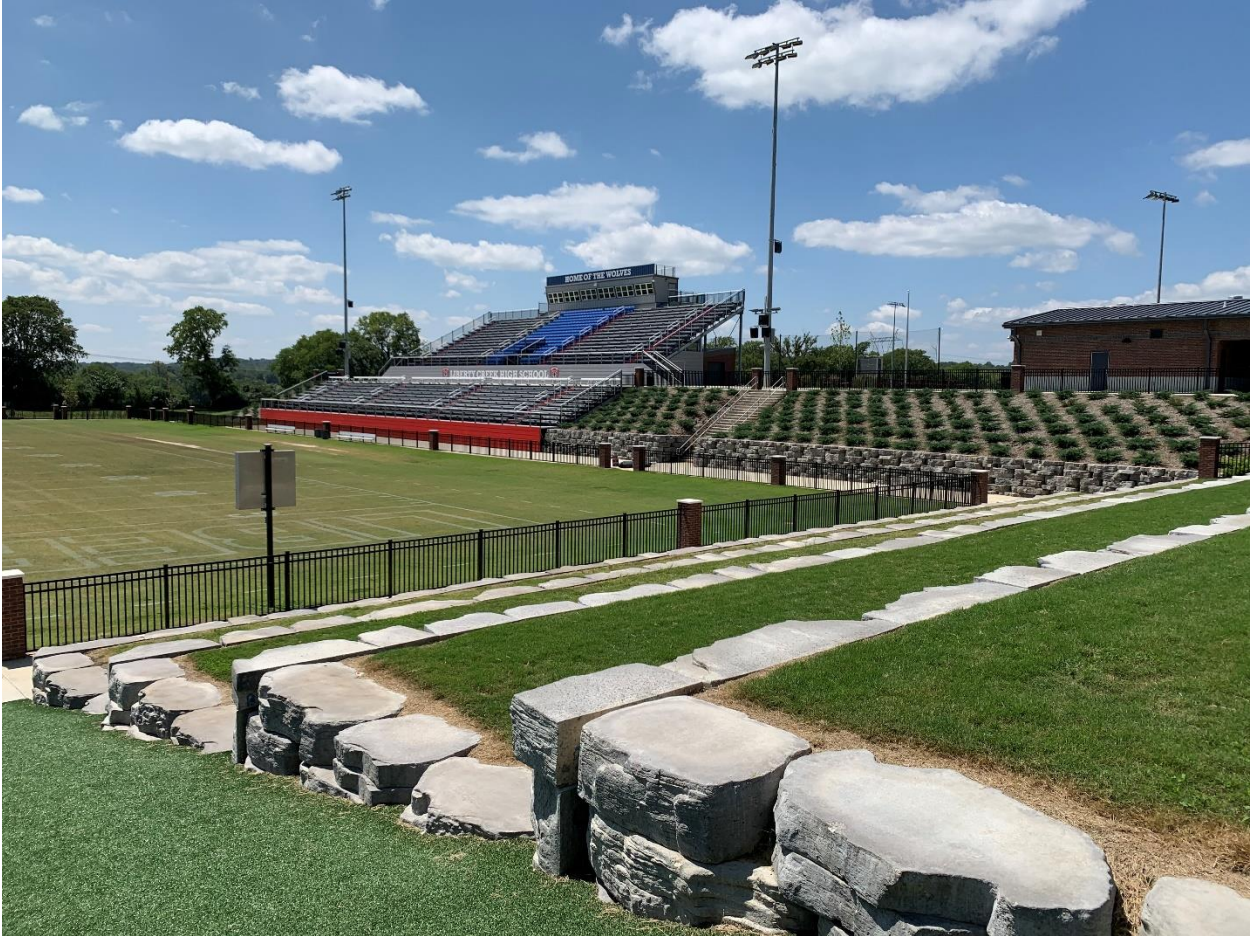
## DESCRIPTION OF STRUCTURE

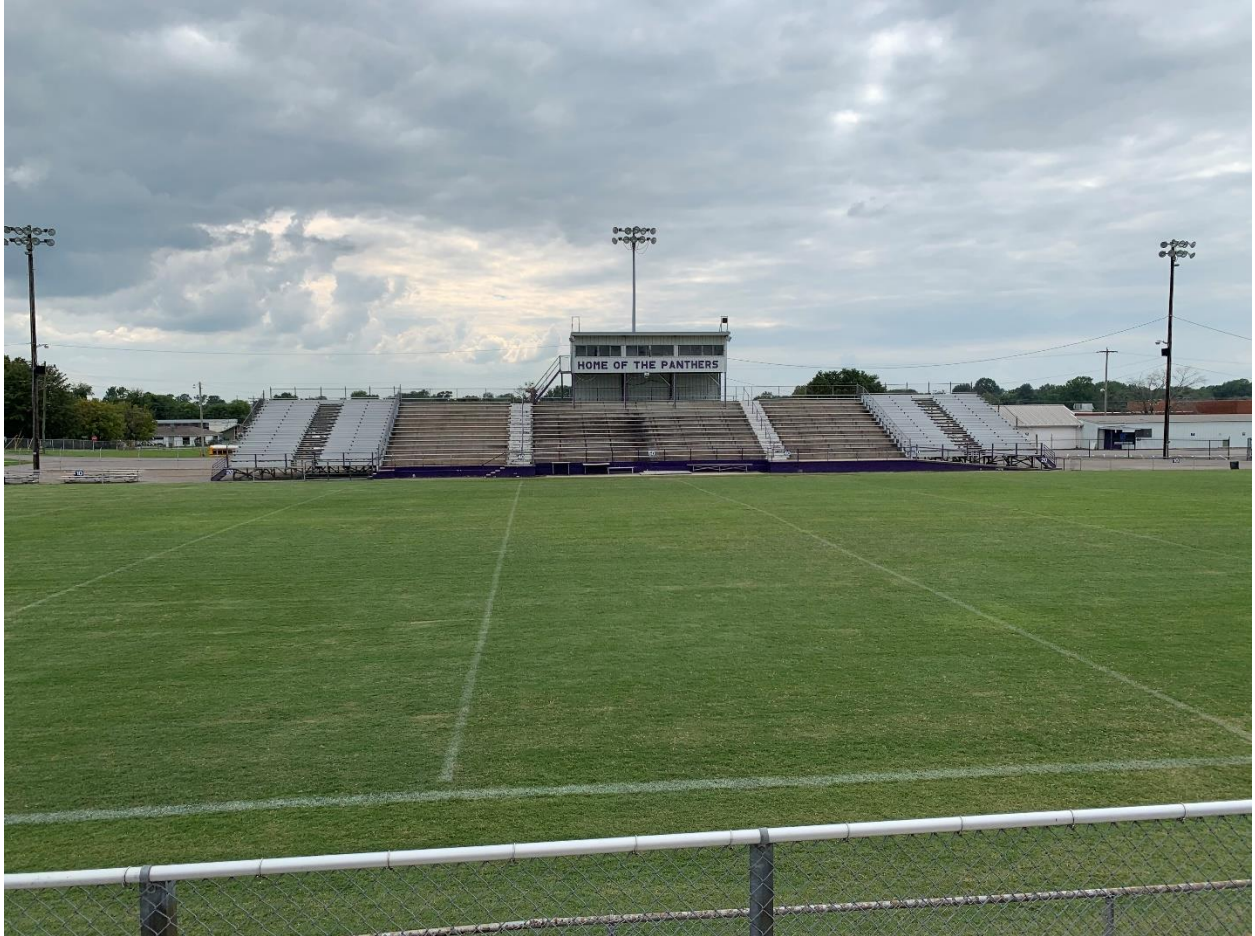
## DESCRIPTION OF STRUCTURE

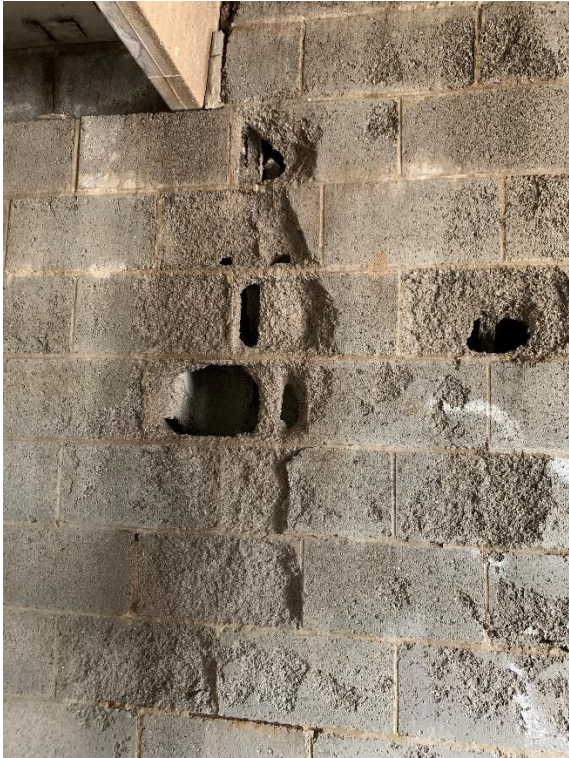
Home side masonry wall with extensive loss of section.

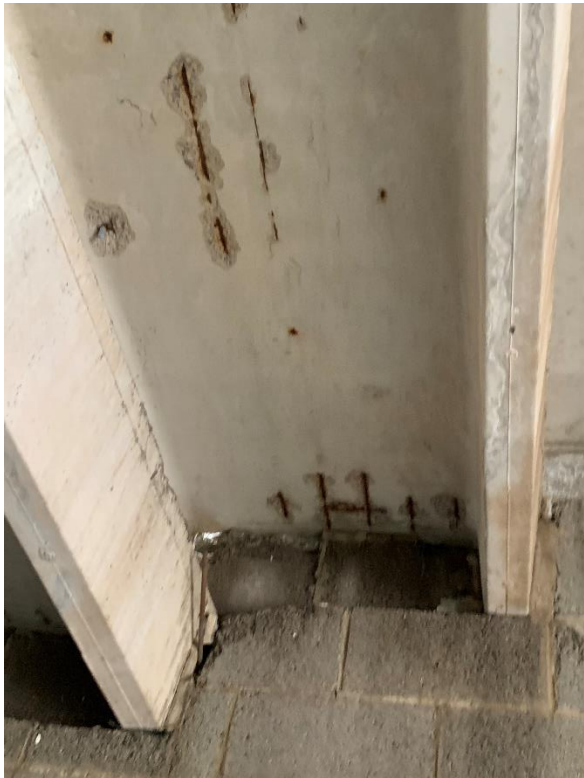
Underside of concrete plank with deterioration of the concrete and exposed steel reinforcing.

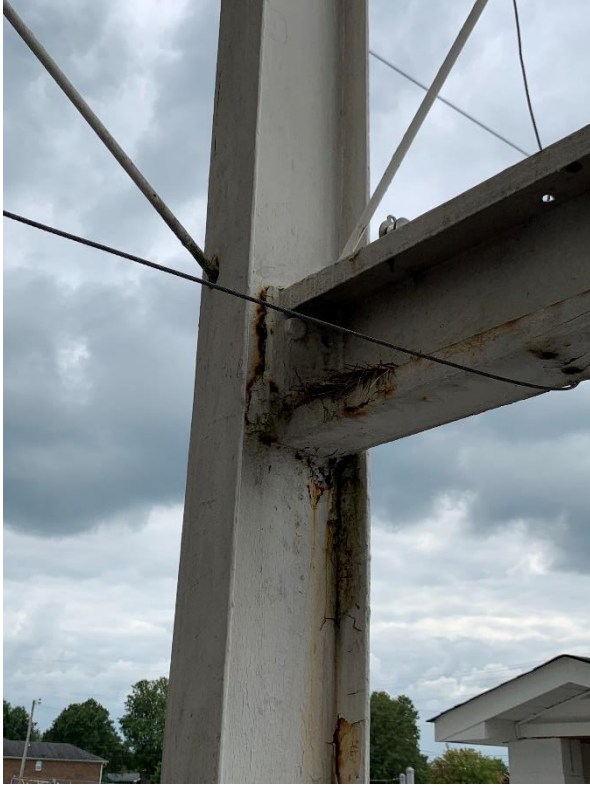
Rusting steel in the column support of the Home side press box.

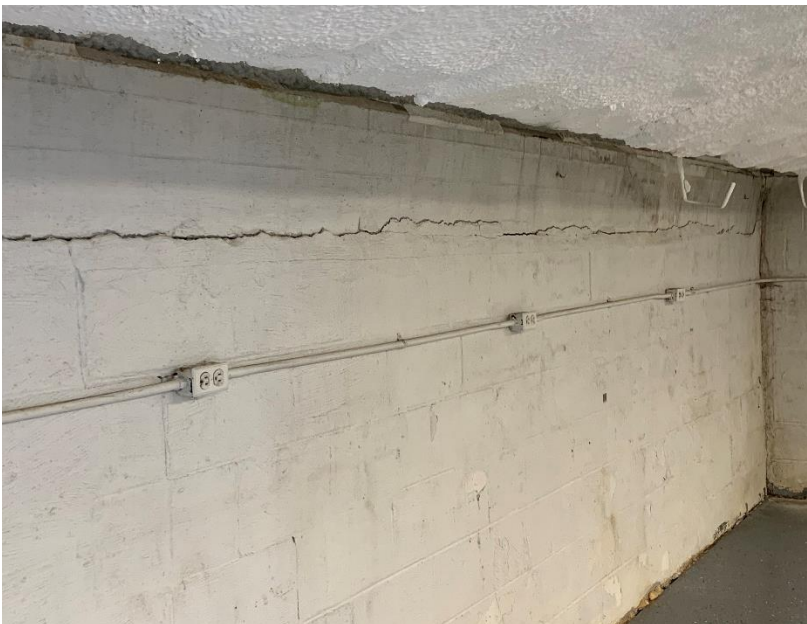
Cracking along the length of the top of the skirt wall along the front of the Home side bleachers.

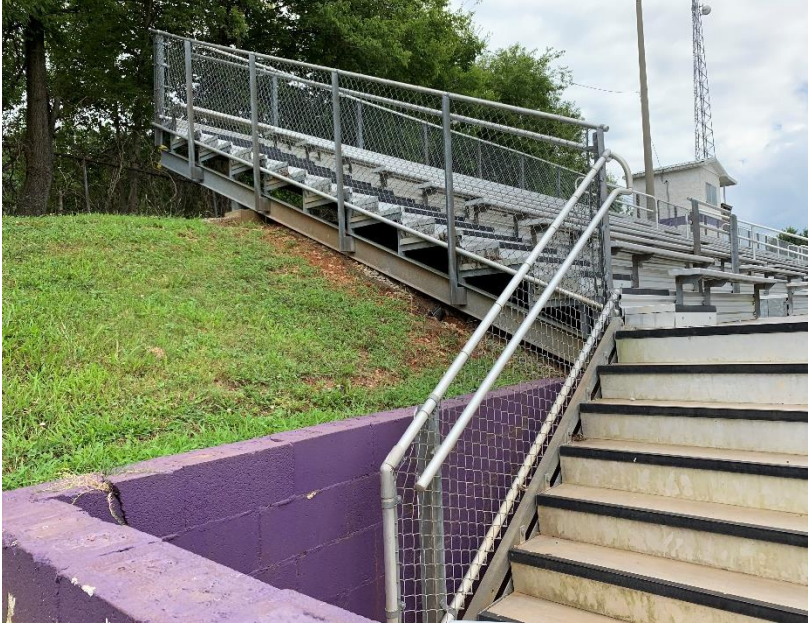
Side view of Visitor side galvanized steel bleachers built into the hill.

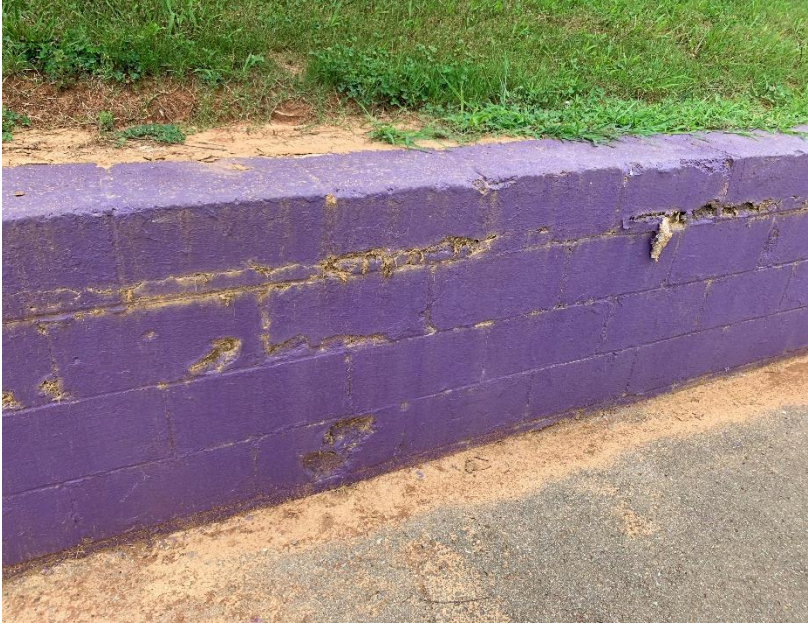
Deterioration of retaining wall along the Visitor side path to concessions.

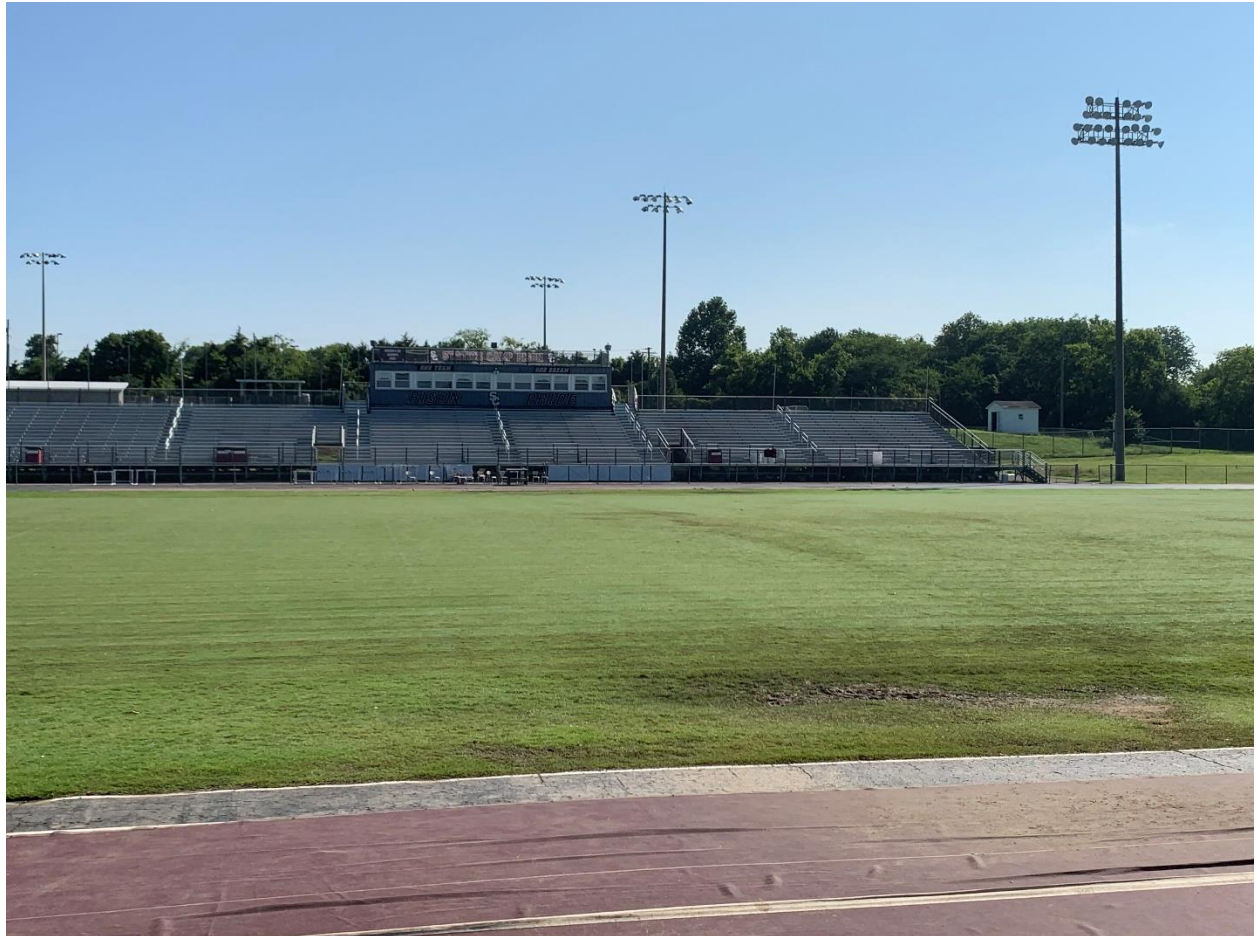
## DESCRIPTION OF STRUCTURE

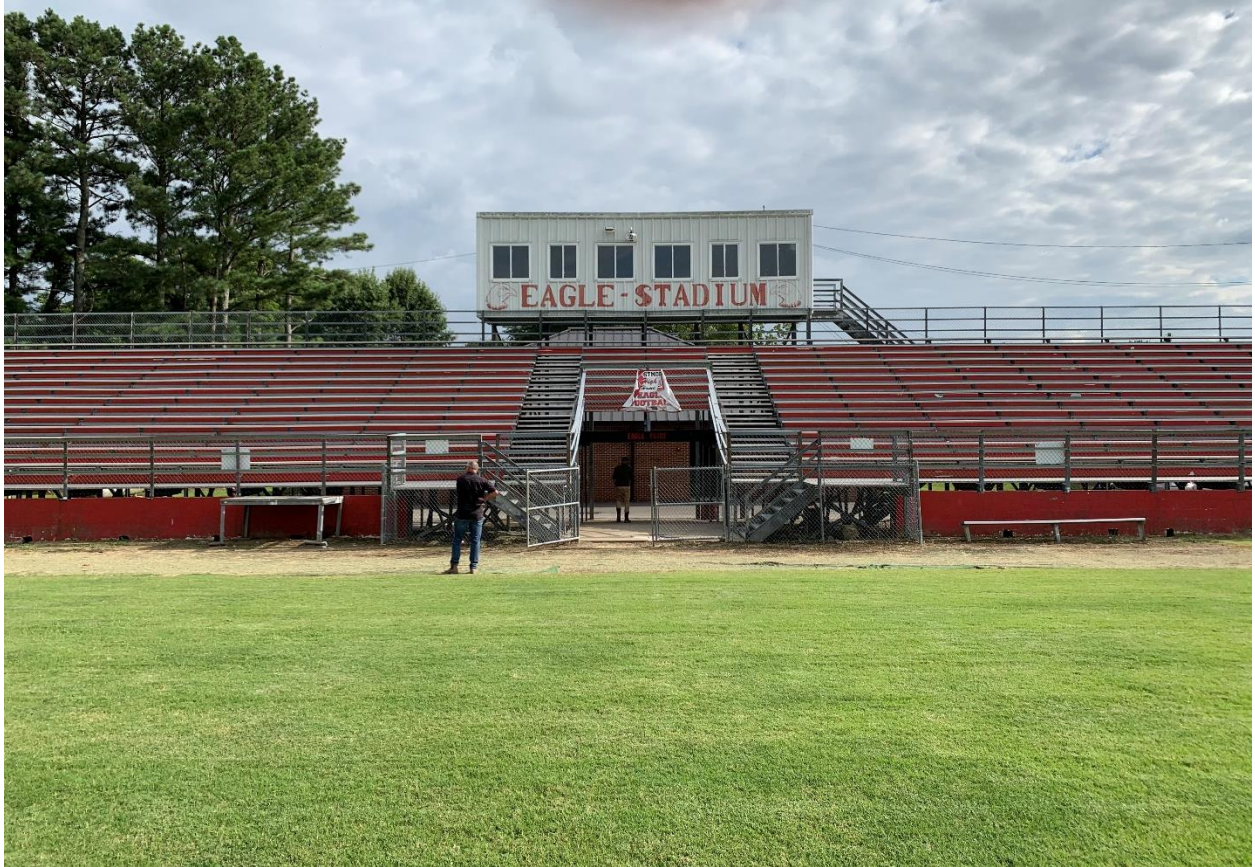
## DESCRIPTION OF STRUCTURE

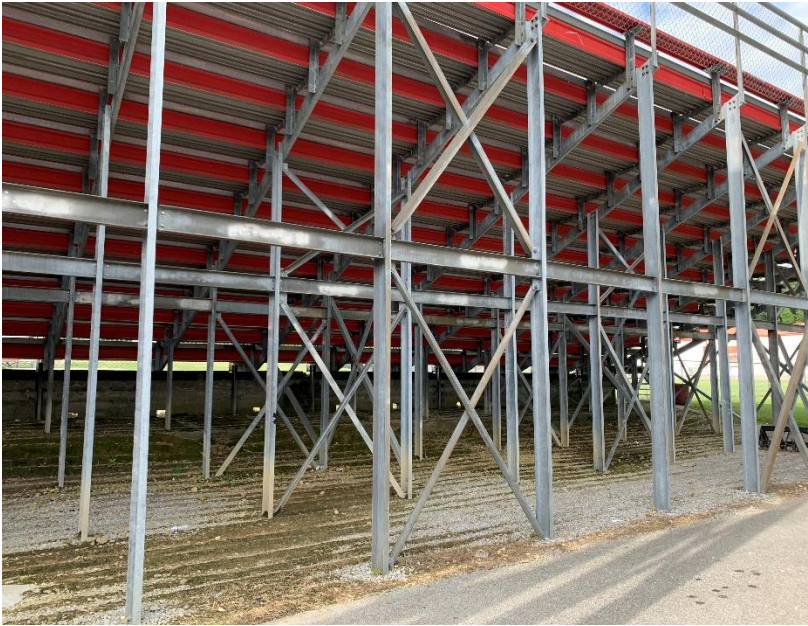
Back side of Home side bleachers with buried base plates.

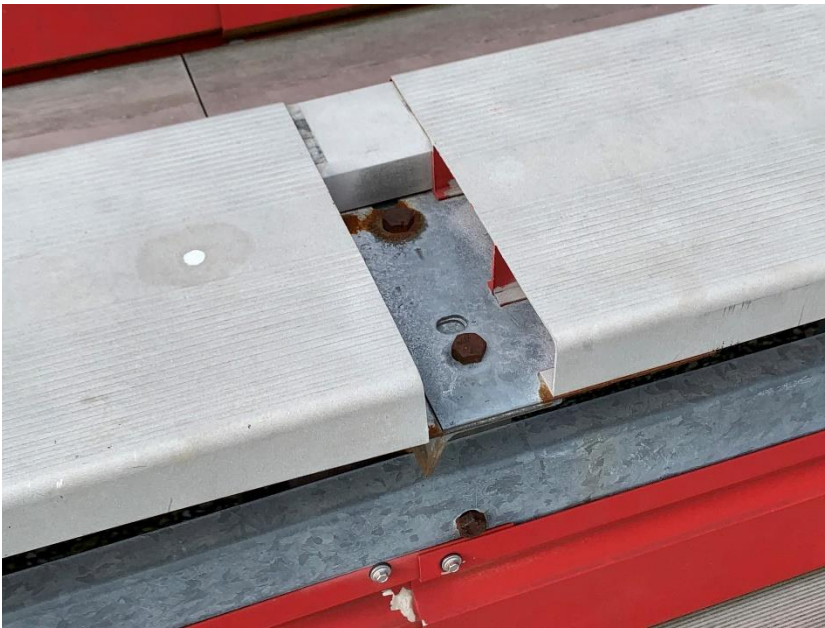
Example of rusted bolts needing replacement.

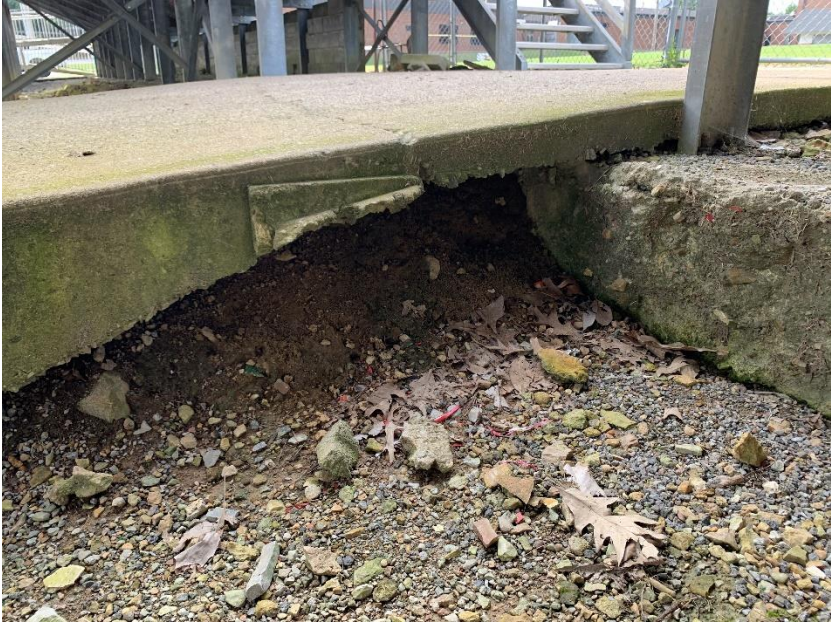
Undermining of concrete walkway at center entrance to Home side bleachers.

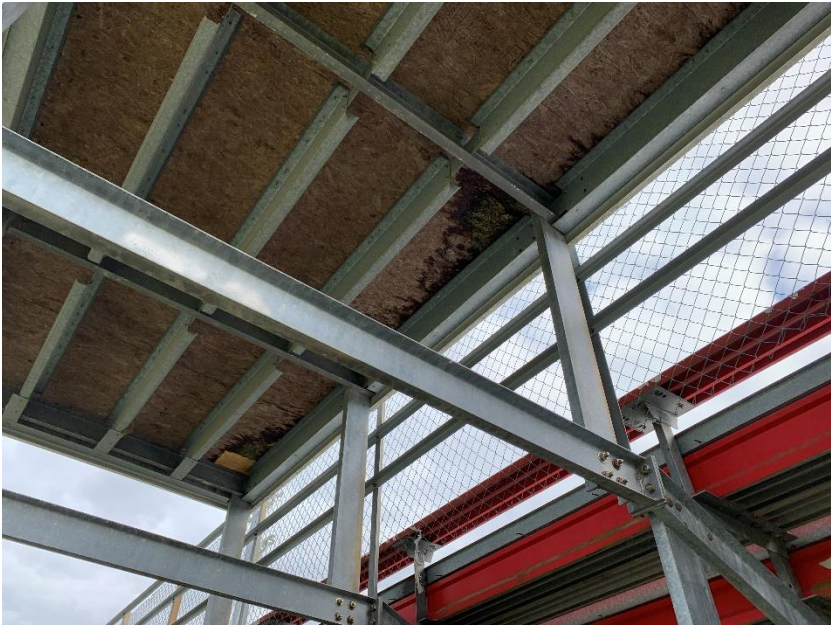
Water damage to the floor of the Visitor side press box.

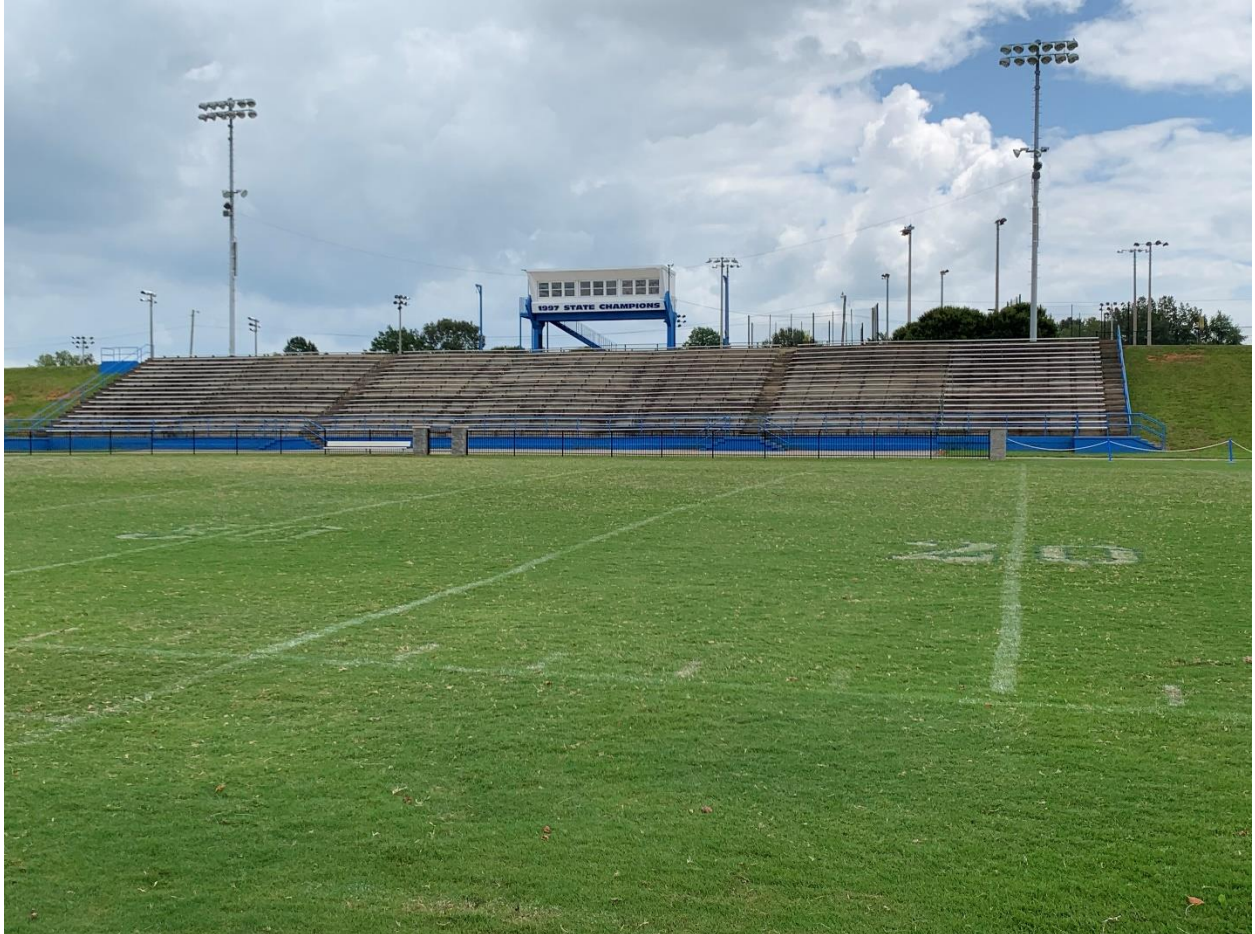
## DESCRIPTION OF STRUCTURE

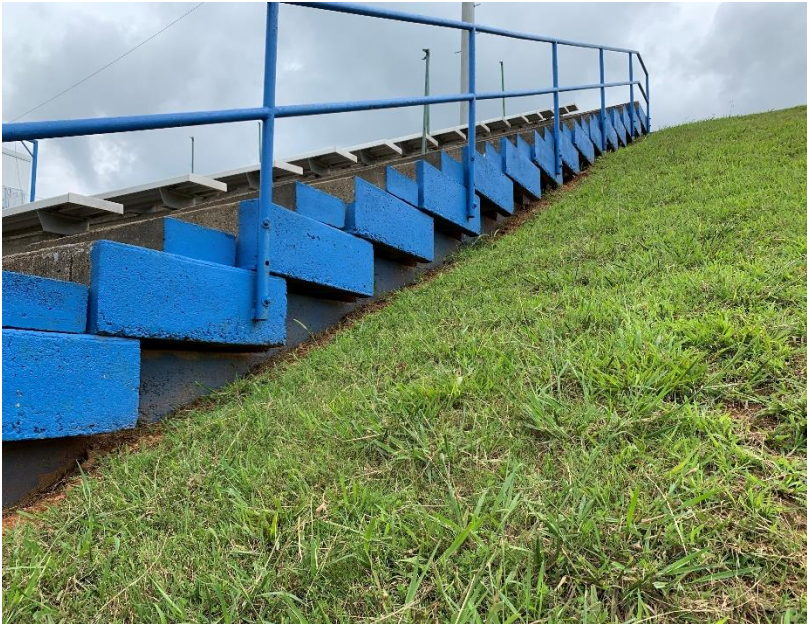
Side view of Home side bleachers.

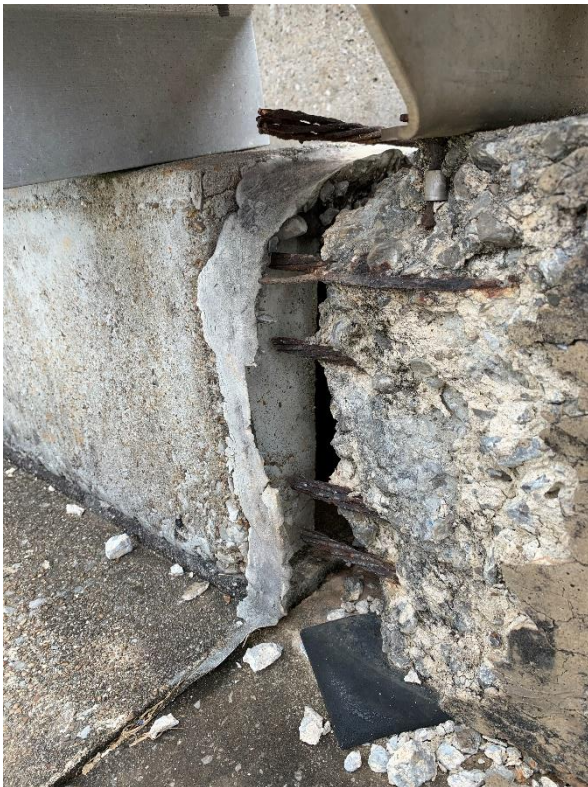
Example of deterioration in concrete plank with exposed reinforcing.

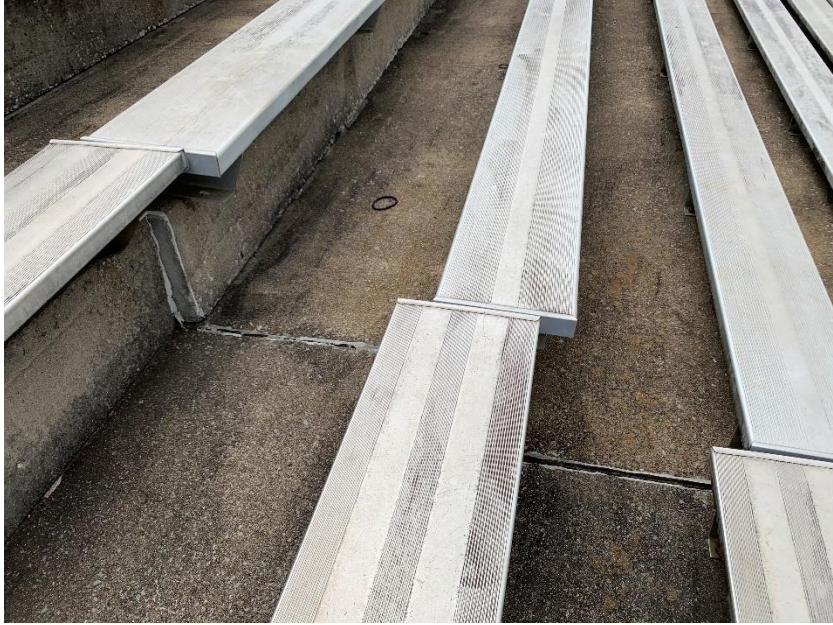
Far-right section of Home side bleachers with plank displacement.
