**KAATZ, BINKLEY, JONES, & MORRIS ARCHITECTS, INC.**  
**ARCHITECTS – ENGINEERS – EDUCATIONAL PLANNERS**

William T. Morris, AIA    Larry D. Marvel, AIA    Gary C. Kromer, RA    Jason Morris, AIA

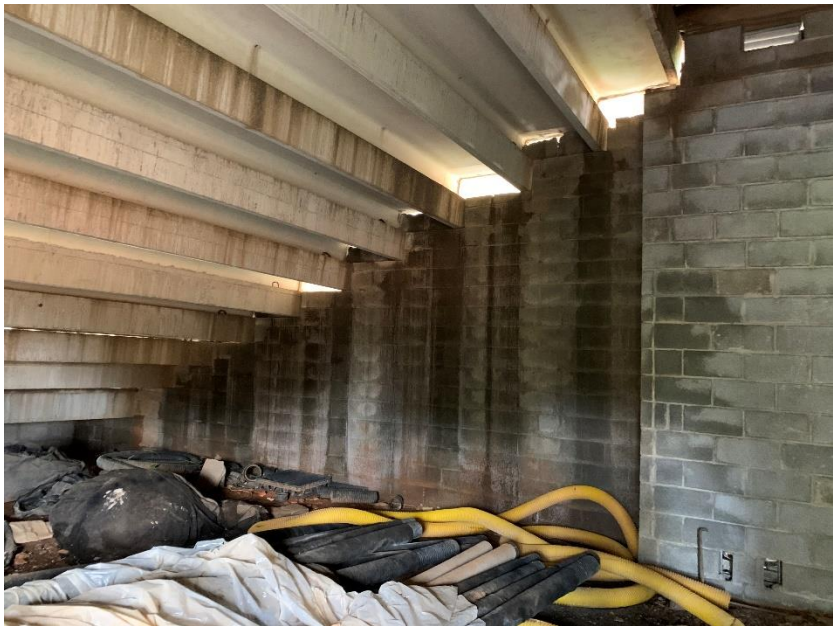
Example of missing block between stems of concrete planks to reduce water infiltration.

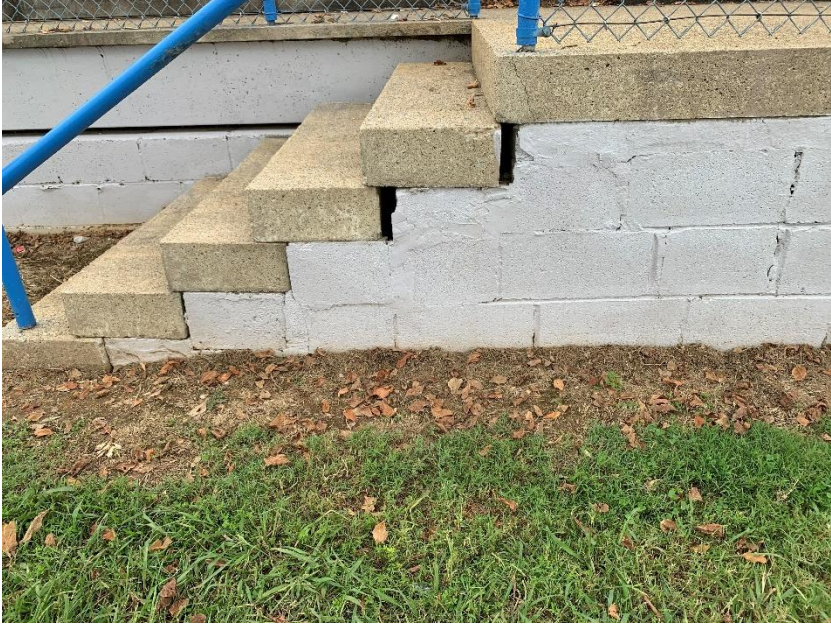
Egress steps requiring repair to realign the riser.

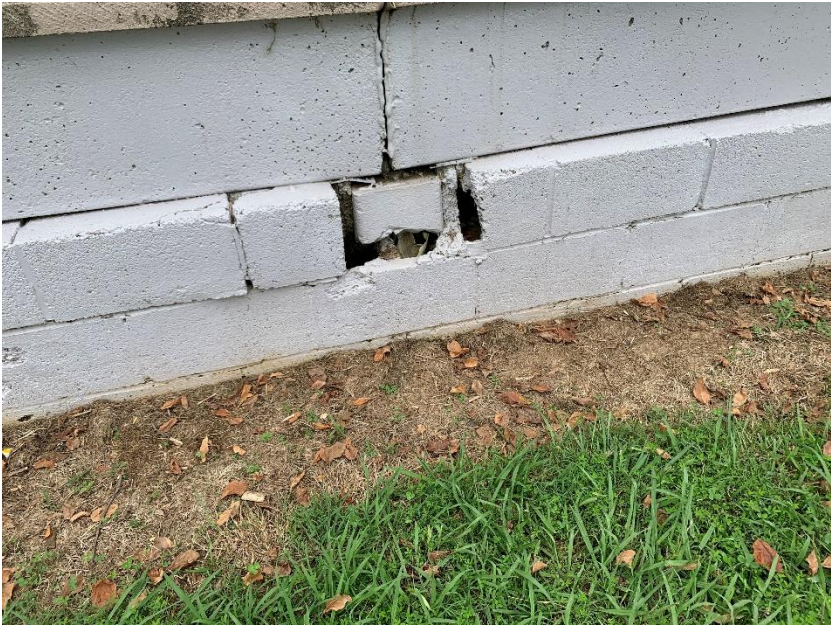
Location for repair front skirt wall at intersection of masonry support wall.

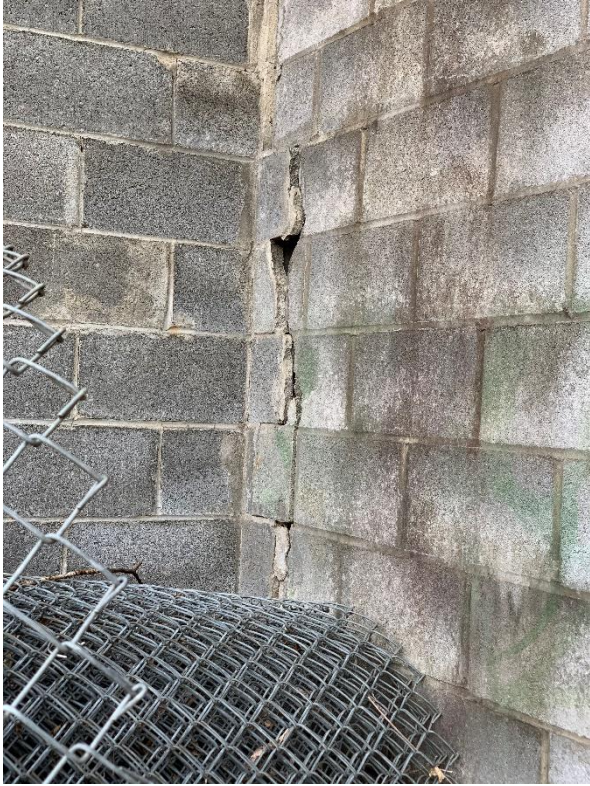
Crack in Visitor side rear wall requiring repair.
